THE GOOD THE BAD & THE UGLY

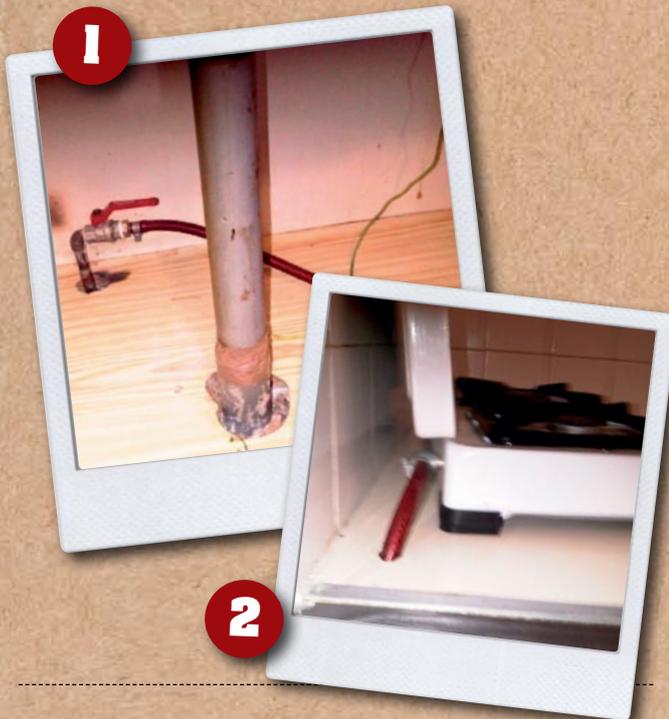
Photographs 1 & 2

George Fraser of GL Heating noticed this gas hotplate connected with garden hose and jubilee clips while visiting friends in a rented flat. George contacted the landlord and the appliance was disconnected and the supply capped.

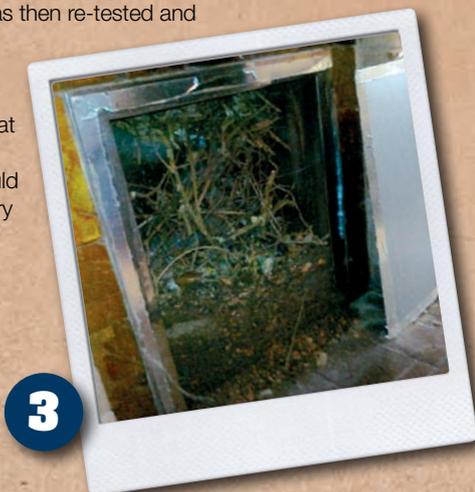
Photograph 3

Anthony Sandford of Pride Plumbing Services was called to a house where the fire had not been serviced for eight years.

On checking the catchment area, he was amazed at the level of twigs and debris that had mounted up behind the appliance: it filled three black bin liners. The chimney was then re-tested and the fire re-connected. He explained to the customer that this is why gas appliances should be serviced every year.

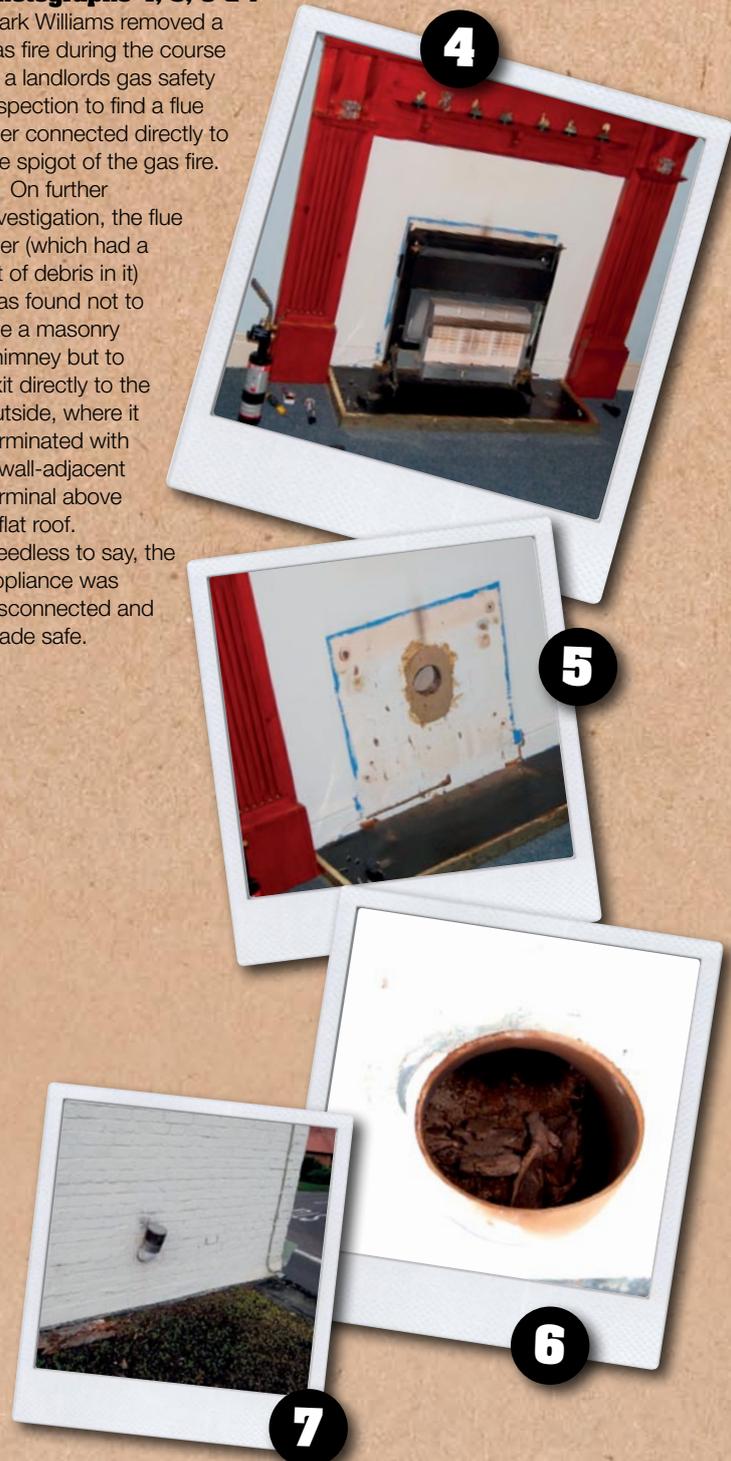
Photographs 4, 5, 6 & 7

Mark Williams removed a gas fire during the course of a landlords gas safety inspection to find a flue liner connected directly to the spigot of the gas fire.

On further investigation, the flue liner (which had a lot of debris in it) was found not to line a masonry chimney but to exit directly to the outside, where it terminated with a wall-adjacent terminal above a flat roof. Needless to say, the appliance was disconnected and made safe.

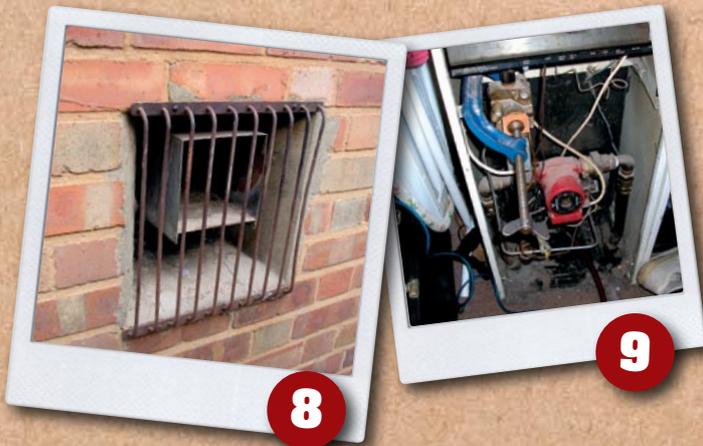
Photographs 8 & 9

Geoff Beck was called out in response to a smell of gas. The balanced flue terminal had been removed many years ago to allow more room on a path at the side of house. The other picture shows a G-clamp holding open the appliance gas valve. It has now been replaced with a new condensing boiler.

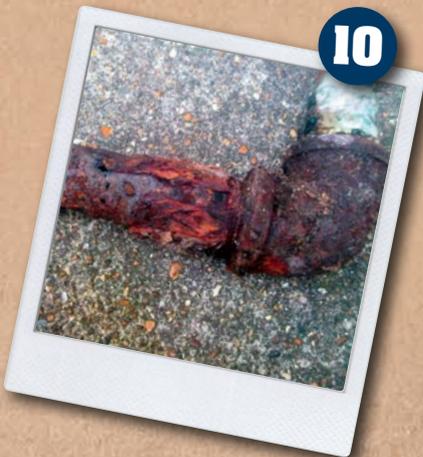
Photograph 10

Mick Andrews of Reading shows us why steel pipework should be protected against corrosion. The customer had noticed a smell of gas outside their property and the gas escape was traced to this badly corroded steel pipe. It was replaced with new copper pipe.

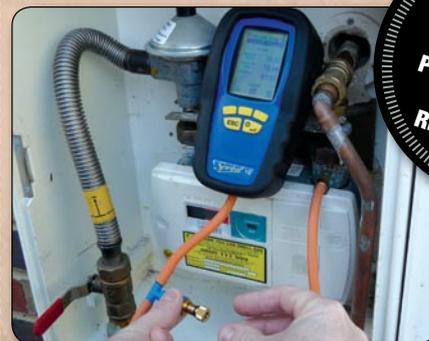
This month Anton are giving away a CPA1 probe kit plus a pressure relief valve, which is designed to simplify let by and tightness testing. It enables you get the desired gas pressure on your U gauge/pressure meter without having to keep pulling off the hose and making repeated adjustments.
